BELZONA PROTECTS MIXER BLADES FROM ABRASION

A scheduled outage for major plant repairs included the remediation of damaged mixer blades with Belzona elastomers.

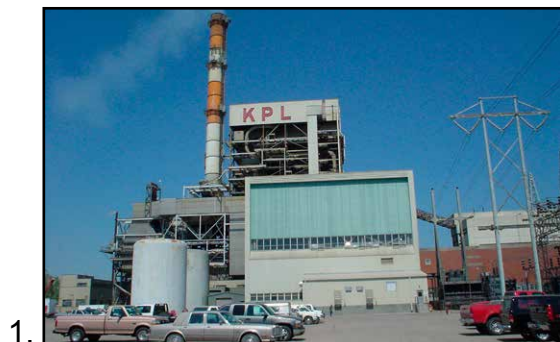
The mixer blades in this crystallization tank exhibited serious damage due to abrasion. This is a very important component in the Flue Gas Desulfurization system.

1. View of the plant
2. Close-up view of the damaged mixer blades
3. Preparing the surface of the blades prior to application
4. Completed application

The Belzona trained contractor mechanically prepared each blade prior to rebuilding to the original contour with Belzona 2111. Then, the blade circumferences were further protected with multiple coats of Belzona 2131.
