BELZONA REPAIRS AND PROTECTS CHIPPER DISC POCKETS

Plywood mill core chipper disc.

Excessive wear in the chipper disc pockets was damaging the chips.

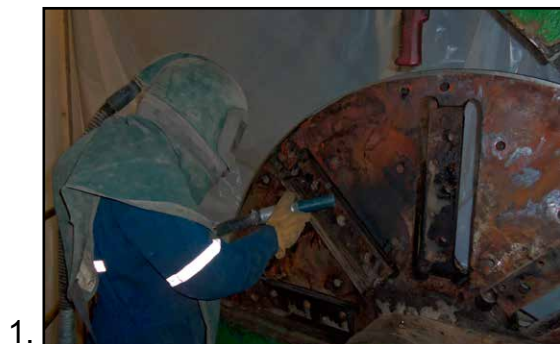
1. Grit blasting the chipper disc pockets
2. Pocket ready for application of Belzona 1811
3. Pocket from front side showing counter knife in place, Belzona 1811 in the pocket
4. Smoothing Belzona 1811 with soap and water to prevent chips from sticking

The chipper disc pockets were sweated and grit blasted in place. Belzona 9411 was brushed onto the new counter knives. The counter knives were installed and Belzona 1811 was applied in the pockets. After a partial cure, water mixed with dish soap was used to smooth the surface so the wood chips would not clog the pockets. The application was carried out in accordance with Belzona Know-How System Leaflet SHM-13.
