BELZONA IMPROVES WORKING CONDITIONS BY SEALING THE ROOF OF A CHOCOLATE FACTORY

Poorly insulated roof

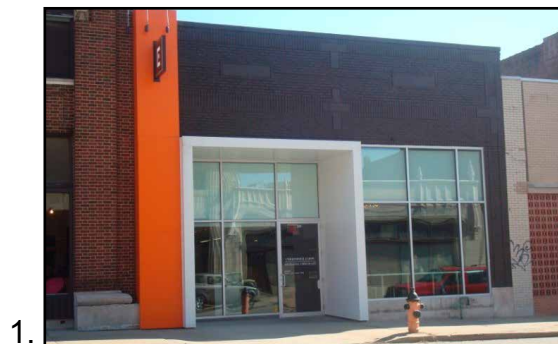
1. Storefront image
2. The roof prepared and ready for application
3. Picture of the first 1/2 of sprayed Belzona 3111
4. Picture of finished installation of Belzona 3111, including repaired parapets

The roof was pressure washed and the parapets were re-pointed with Belzona 4111. The roof was then completely sealed and protected with the Belzona 3111 system. The application was carried out in accordance with a modified version of Belzona System Leaflet RPA-10.
