## BELZONA WATERPROOFS FLASHINGS SAVING MILLIONS OF DOLLARS OF PRODUCT

Roof flashings

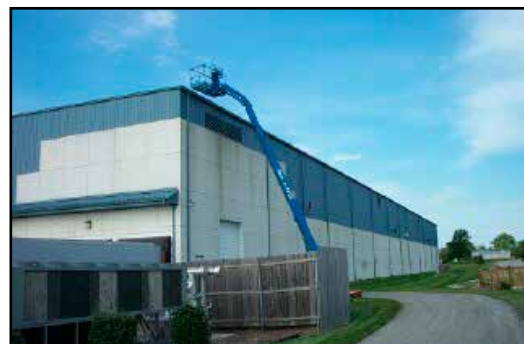
1. Picture of Warehouse/Storage Structure
2. Picture of the damaged flashing in need of repair
3. Close-up of Belzona application
4. Completed Belzona repair of 80 linear feet of flashing

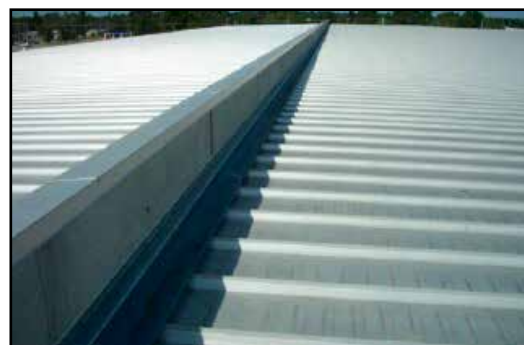
2.

The material used to seal the flashings on this firewall had become brittle and cracked, creating fissures for water to seep into the building. A solution was needed that was both flexible and UV stable to protect this pharmaceutical storage facility housing millions of dollars of product.

The application was carried out in accordance with Belzona Know-How System Leaflet RPA-8 using the fully reinforced Belzona 3111 system.

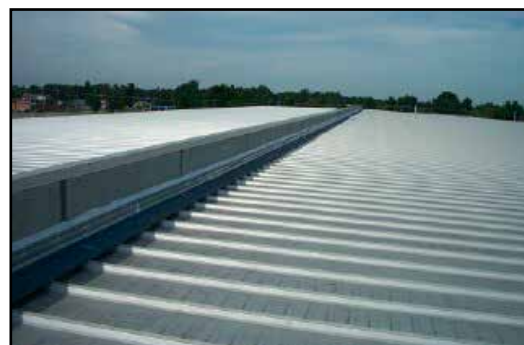
4.

Due to past success with roof repairs for this pharmaceutical facility, Belzona was the confident choice. 850 linear feet of flashing was completely sealed and protected in two days. Inspected in 2012, the repair is still perfect.
