BELZONA SAVES PUMP FROM REPLACEMENT

CUSTOMER
MO, USA

APPLICATION DATE
December 2003

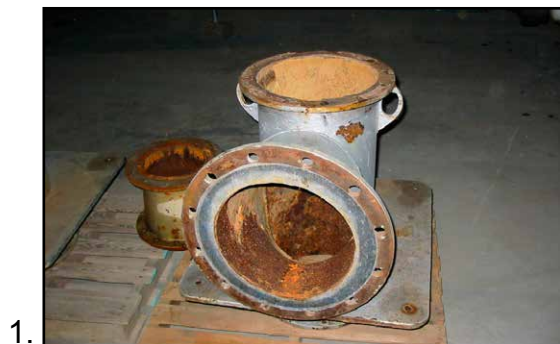
1. Overview of the pump
2. Sever corrosion damage to the pump
3. Completed application
4. Completed application

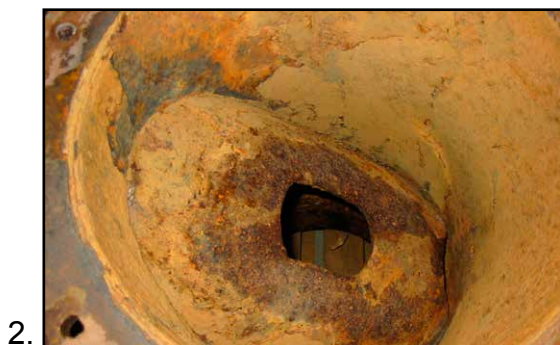
The pumps from one of this well-known amusement park's water rides had badly corroded with severe loss of metal. The corrosion was so thick that the pumps required grit blasting three times to achieve a proper profile. A solution was sorely needed.

The most severe corrosion areas were repaired with Belzona 1121 followed by two coats of Belzona 1341 to provide a long-lasting, super slick surface. The application was carried out in accordance with Belzona Know-How System Leaflets CEP-1 & CEP-10.
