BELZONA STOPS WATER DAMAGE TO AN OFFICE BUILDING

APPLICATION SITUATION
Roof leaking

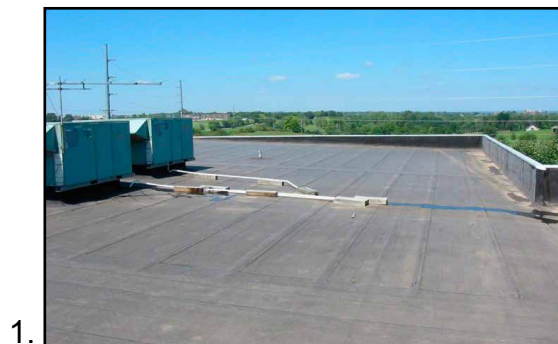
1. View of the roof
2. Roof is prepared, conditioned & reinforcement done where needed
3. Belzona application commencing
4. Belzona application completed
