BELZONA SAVES GENERATOR EQUIPMENT FROM WATER DAMAGE

Emergency generator room at a hydro dam.

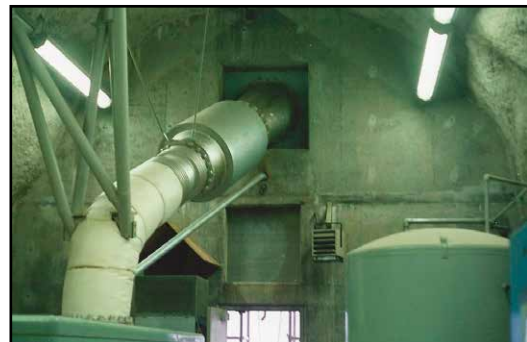
The spillways at this dam shoot the water up into the air, causing the spray to wet the outside walls of the emergency generator room. The water enters from all of the construction joints as well as the exhaust vent.

1. Inside the emergency generator room
2. Applying Belzona 3111 on the outside wall
3. Applying Belzona 3111 on the outside wall
4. Emergency generator room seen from across the river. The entire powerhouse is inside the mountain.

The application was carried out according to Belzona Know-How System Leaflet RPA-1 in order to seal all of the construction joints and the exhaust pipe.
