## ROOF PROTECTION TO RESERVOIR VALVE TOWER

Blackburn, UK

June 2014

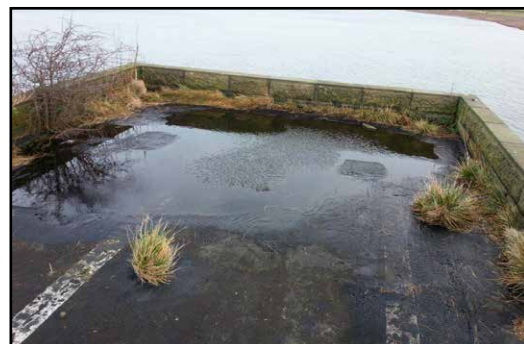
Damage to asphalt coated roof causing water ingress resulting in spalling concrete underneath. There was also severe plant growth.

1. Standing water causing damage
2. Damage to substrate
3. Completed Repair
4. Isolated Location

The application was carried out in accordance with FPA-1, RPA-1 and RPA-6. All of the damaged asphalt and plant growth was removed and the damaged concrete was rebuilt with Belzona 4131. Belzona 3131 was subsequently applied to the entire area to prevent further water ingress.
