## BELZONA EXTENDS THE LIFE OF THE SHAFT

**APPLICATION SITUATION**  
Coke shaker keyway.

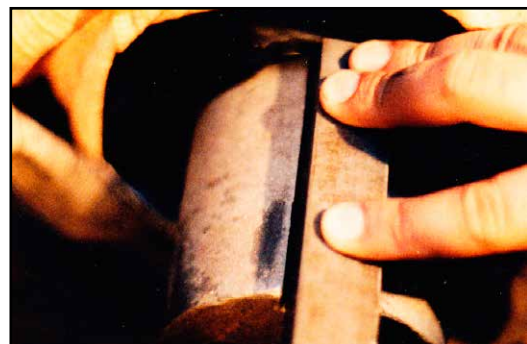
**PROBLEM**  
The shafts in this coke shaker really take a beating. It was believed that the keyway was machined oversize by mistake. The sheave was also loose on the shaft.

1. Showing the wear on one side of the keyway
2. Key in place and Belzona 1111 on the shaft
3. Completed application and equipment reassembled, ready to shake

**APPLICATION METHOD**  
Application was carried out in accordance with Belzona Know-How System Leaflet MPT-4. The keyway was formed in place using a new key. Because the shaft was also slightly undersized, it was ground as well. Belzona 1111 was applied all the way around the shaft and the sheave was replaced, centering the key.
