## BELZONA REBUILDS PUMP IMPELLER

Circulating Water Pump in Potato Processing Plant

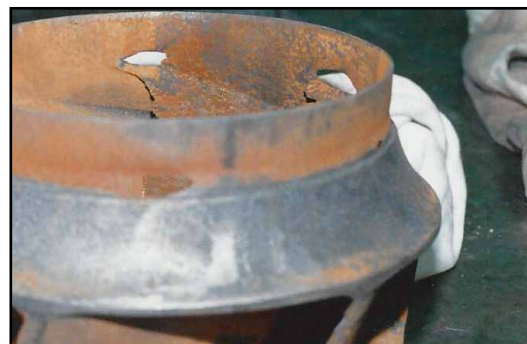
The pump had worn beyond repair so was tossed in the scrap pile.

1. Damaged impeller showing holes.
2. Worn impeller vanes.
3. Impeller rebuilt with Belzona 1311.
4. Finished impeller with two coats of Belzona 1341.
