BELZONA EXTENDS THE LIFE OF HYDRAULIC RAMS

Plywood press with scored hydraulic rams.

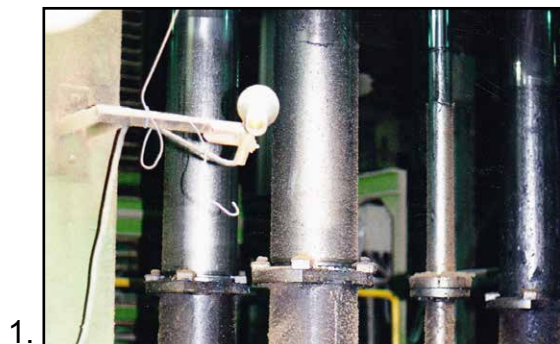
Three hydraulic rams had been scored and the loss of oil was so bad that they had built a dam so the oil would drain into a 55 gallon drum. At the end of each shift the oil was pumped back into the reservoir. They had tried repairing the score with another material, but it fell off after one pass.

1. Plywood press showing damaged hydraulic rams
2. Rams repaired
3. Close up of one repaired ram

The application was carried out in accordance with Belzona Know-How System Leaflet MPT-3. The damaged area was so large that a straight edge could not be used. We ground a shoulder following the damage, drilling the corners to keep the edges square.
