OFFSHORE OIL PLATFORM HEAT EXCHANGER TUBE SHEETS

Heat exchanger tube sheets

One year old tube sheets already leaking around the tubes. Electrolysis has eaten away much of the tube sheet and plate.

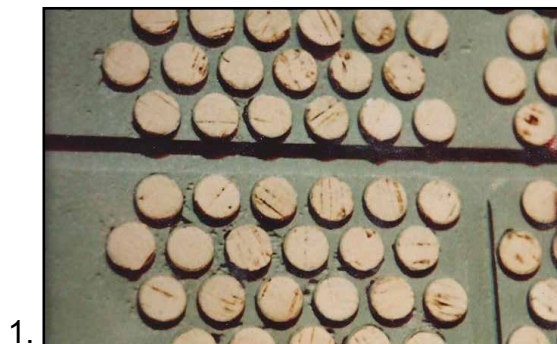
1. Tube sheet with corks inserted
2. Applying Belzona 1311, then 2 more coats of Belzona 1321
3. Breaking corks loose with wood dowel
4. Pulling corks with a cork screw
