BELZONA REPAIRS CRUSHER'S BASE

Mine, BA, Brazil

January 2006

Interior of the crusher's base.

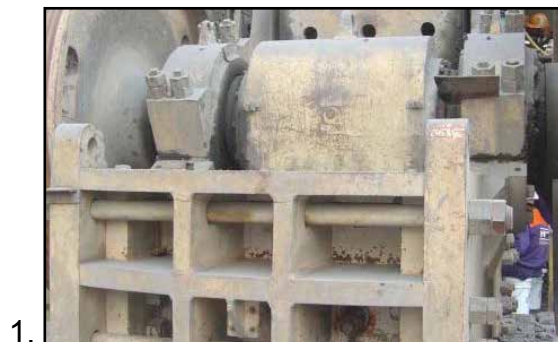
1. General view of the crusher
2. Crusher's base with exposed metal structure
3. Application of Belzona 4111
4. Crusher's base repaired with Belzona technology

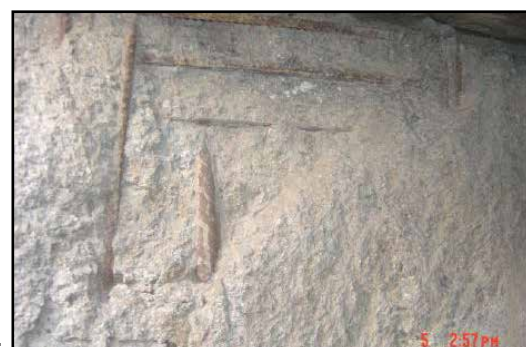
2.

Over time, the vibration of the 100 ton machine caused the breakage of two fastening screws of the concrete base. The equipment became tilted and some parts of the concrete were already showing the metal structure, causing their oxidation. It was necessary to recover the surface with a concrete repair product with excellent mechanical resistance.

The application was carried out based on Belzona Know-How System Leaflet FPA-1. Surface was prepared with abrasive grit blast and wire brush. After that, the conditioner Belzona 4911 was applied on the concrete and Belzona 4111 was applied to fill out the damaged areas and to rebuild the corner of the base.
