## BELZONA PROTECTION FOR NUCLEAR POWER STATION CW VALVES

Nuclear Power Station, UK

Butterfly valves controlling main cooling water inlets.

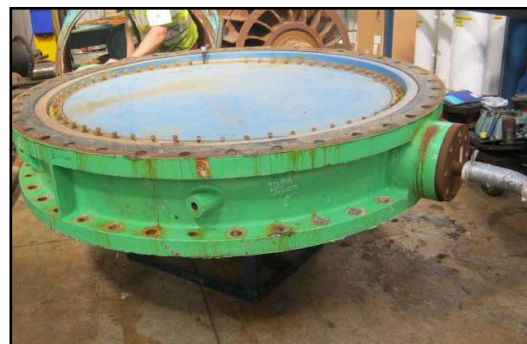
1.

### PICTURES

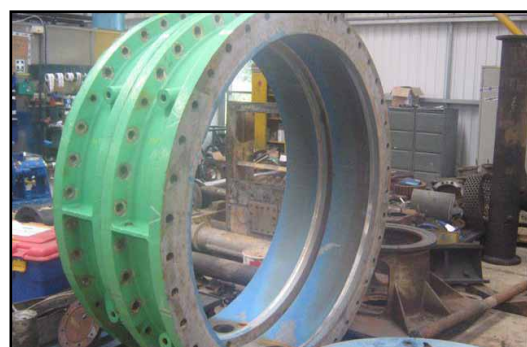
2.

The non-pressure side of the valve had severely eroded due to corrosion and cavitation. The valve body and particularly the disc were affected.

Application was carried out in accordance with Belzona Know-How System Leaflets VPF-1 & VPF-2. A hot chemical wash was used to remove salt contamination before completing the surface preparation and coating. The valve disc was coated with 3 coats of Belzona 2141 to provide maximum cavitation resistance. The valve body was protected from erosion-corrosion using Belzona 1321. In both cases the original profiles were restored by rebuilding with Belzona 1311.
