BELZONA APPLIES ANTI-CORROSIVE COATING ON A THICKENER

Mine, PA, Brazil

Thickener.

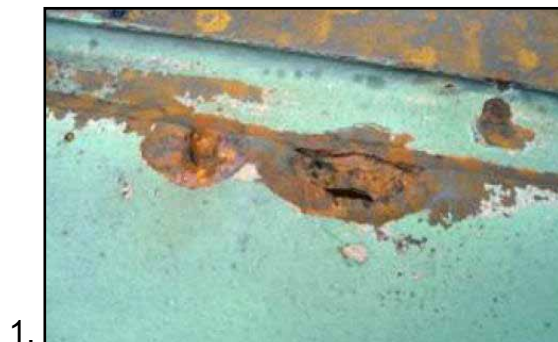
The wall area and the bottom of the thickener presented areas with localized corrosion, which needed thickness and internal lining repair. In addition protection of the steel plate against corrosion, caused by copper pulp at room temperature, was required.

1. Hole on the bottom of the thickener
2. Hole on the wall of the thickener
3. Supporting beam on the bottom of the thickener coated with Belzona 1321
4. Wall coated with Belzona 5831

The coating was applied on half of the internal area of the wall and on half of the support beams of the bottom of the thickener based on Belzona Know-How System Leaflets TCC-1 and TCC-5. First, the thickener was washed to remove the copper ore residues. Following the surface preparation, with dry abrasive blast to achieve near white metal finish, the holes, pits and existing welds were repaired with Belzona 1311. After that, Belzona 1321 was applied on the bottom of the thickener, and Belzona 5831 was applied on the wall.
