BELZONA SAVES CORRODED SPRINKLER TANK BY PLATE BONDING

Industrial Foam Manufacturer, Northamptonshire UK

December 2013

6m diameter x 6m high circular steel panelled tank supplying water 24 hours a day / 7 days a week for the internal fire sprinkler safety system in a large foam product manufacturing plant

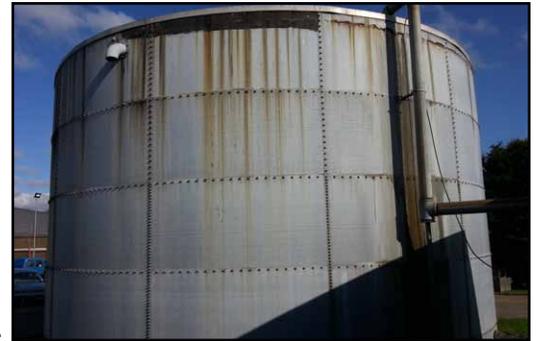
Over several years the tank had become badly corroded at the water line around approx. 50% of the circumference, causing it to split open in some areas with water constantly flowing out.

1. Large sprinkler tank with corrosion at water line
2. Surface being prepared with MBX Bristle Blaster
3. 36 off 400mm long x 300mm high steel plates being installed using Belzona 1161
4. Installation of steel plates completed and coated with Belzona 5831
