BELZONA REBUILDS WORN STONE STAIRCASES BUILT IN 16TH CENTURY

College in Cambridge, UK

Badly worn stone steps on staircases built in the 16th Century

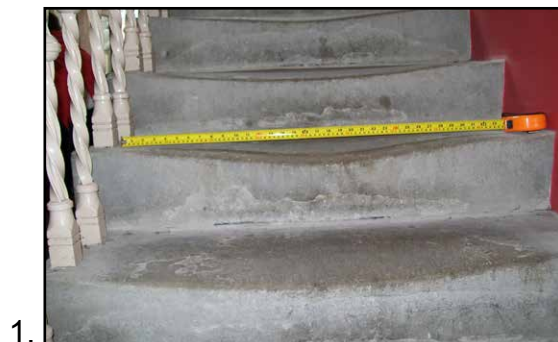
The stone steps on several staircases in this Grade 2 listed College had become badly worn over the last 500+ years of use and so were considered a Health and Safety risk. The steps had worn by up to 75mm deep in the centre, sloping towards the front so were slippery when wet. Due to the design of the stone steps it was not possible to cut out the worn area and repair in the traditional manner of inserting a new block of stone because this would weaken the staircase.

1. Worn stone steps before, with wear up to 75mm deep in centre of step
2. Wooden formers in place and Belzona 4911 being applied
3. Belzona 4131 being installed with wooden former helping keep the repair flat and level
4. Example of step rebuild completed with Belzona 4131
