BELZONA USED IN WINDMILL REFURBISHMENT

Windmill, Buckinghamshire, UK

Old windmill used as accommodation undergoing refurbishment

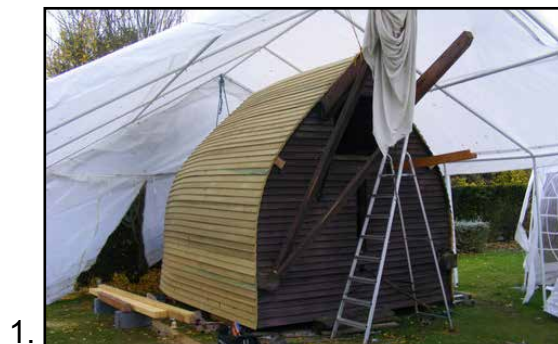
1. The cap on the ground with freshly replaced timbers
2. First layer of Belzona 3111 being applied
3. & 4. Finished application with cap fitted back in place

Once the sails had been removed the wooden cap was taken down and work could commence to replace any rotten or damaged timber. Upon completion of the structural work the fully reinforced Belzona 3111 system was applied in accordance with Belzona System Leaflet RPA-1. With all the overlapping timbers it required the patience of a craftsman to carefully lay the reinforcing sheet into the Belzona 3111 to achieve a wrinkle free finish with the sheet closely following the substrate profile.
