RUBBER LINER IN SLURRY PUMP REPAIRED WITH BELZONA

Rubber lined Warman 10/8M slurry pump.

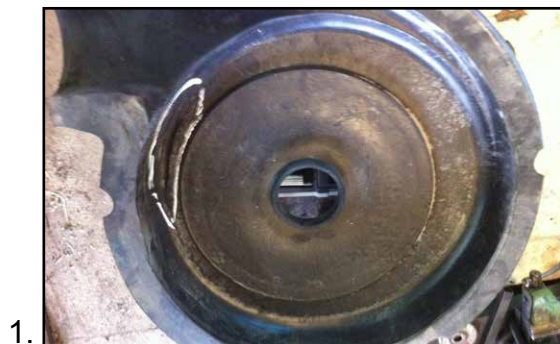
The rubber liner had suffered local damage resulting in an operational shut down.

1. Damaged rubber liner
2. The Warman 10/8M pump
3. Damaged area Conditioned with Belzona 2911 (Elastomer QD Conditioner)
4. Rubber liner after application of Belzona 2311
