## BELZONA SAVES ENGINE BLOCK

The customer provides high end restoration services for vintage cars. Currently working on an Aston Martin DB6 engine block

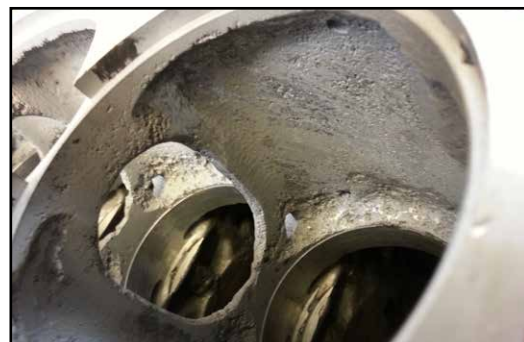
The engine block had a hairline crack and was badly pitted around the cylinder liners. Due to the location of the crack, it was difficult to reach to weld effectively and the pitting needed to be eradicated.

1. The damaged engine block prior to cleaning
2. The block being repaired with Belzona 1111
3. Second coat of Belzona 1392 being applied
4. The finished block
