BELZONA REPAIRS AND PROTECTS SX/EW TANKHOUSE CELL

Copper Mine, Arizona

2011 - 2013

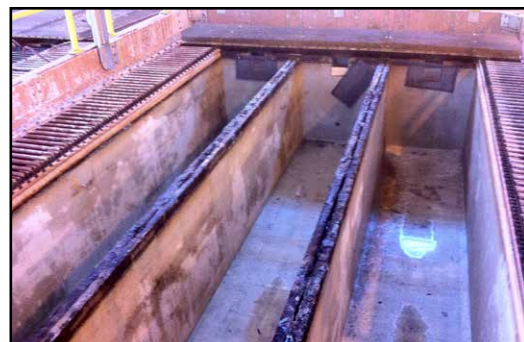
Polymer concrete SXEW process cells had been experiencing cracking which caused leakage of copper sulphate electrolyte solution. The furniture rails which suspend the copper anode plates were experiencing resin burnout from heat transfer through the cathodes.

1. Overview of the tankhouse cell
2. Furniture rails repaired with Belzona 4111
3. & 4. Tankhouse cell protected with Belzona 4341
