## BELZONA COLD PLATE BONDING SOLUTION FOR SLUDGE TANK

Sewage treatment works - UK

Through wall corrosion on sludge tank fabricated from glass coated mild steel.

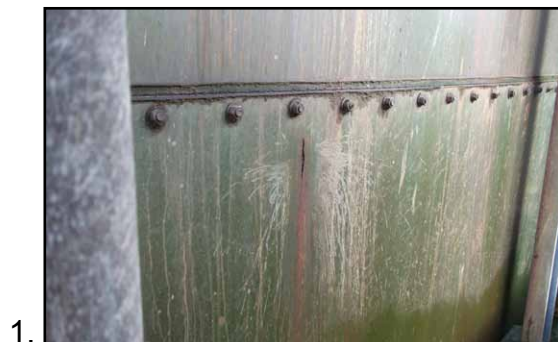
The primary sludge tank was suffering from through wall corrosion at the lowest panel level. The tank could not be taken off line due to demand and any repairs would have to be carried out without hot works or the use mechanical equipment due to the risk of sparks.

1. Through wall corrosion to primary sludge tank
2. Surface preparation carried out by hand abrasion
3. Repair with plate cold bonded over the through wall corrosion using Belzona 1161
4. Completed application
