## BELZONA REFURBISHMENT OF FLAT ROOF

School, Grantham, UK

Large areas of flat roof over the sports and dining areas.

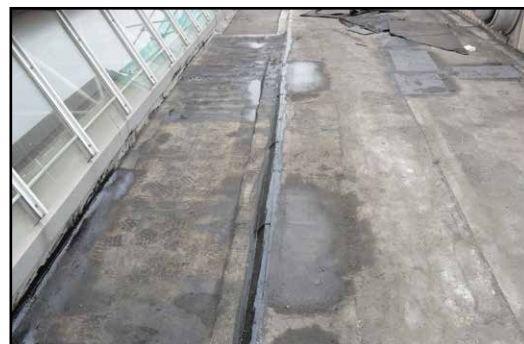
The felt roof had deteriorated allowing numerous leaks into the areas below.

1. Section of roof before work started
2. Completed application
3. Upper section of roof before coating
4. Completed application

Application was carried out in accordance with Belzona System Leaflets RPA-1, RPA-6 and RPA-8. After cleaning the roof and carrying out some localised repairs, a fully reinforced Belzona 3111 system was applied to the entire roof areas.
