BELZONA PROTECTS WASTEWATER PUMP FROM EROSION-CORROSION

Wastewater Plant, Niagara Region, Ontario, Canada

Pumps in a regional Wastewater Authority.

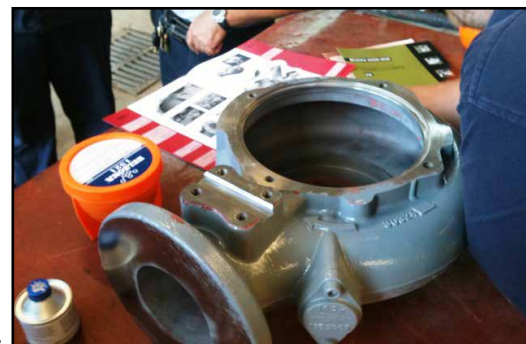
1. View of new cast steel pump volute
2. Prepared surface by abrasive blasting
3. First coat of Belzona 1321 (Grey) applied
4. Second coat of Belzona 1321 (Blue) applied
