## BELZONA REBUILDS DAMAGED STONework

School, West Yorkshire, UK

Weathered stonework on school building.

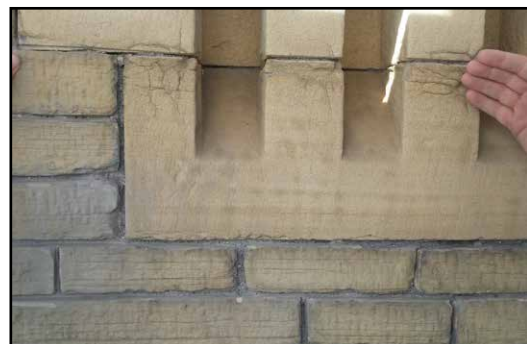
Weathered stonework needed rebuilding to improve appearance and remove risk of falling debris.

1. Before application
2. Local repair to corbel with shape detail
3. Completed application to corbel
4. Completed application to window sill
