## CORRODED AND CRACKED PIPEWORK FIXED WITH BELZONA

Manufacturing company, Slough, UK

Pipework at global paints and coatings company.

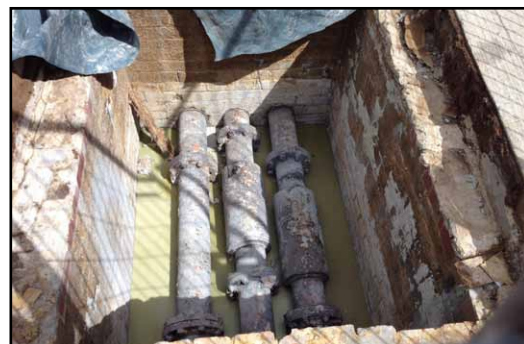
The pipe had corroded and cracked, leaking 10% Sodium Hydroxide.

1. & 2. Cracked and corroded pipework
3. Completed application

Application was carried out in accordance with Belzona System Leaflet VPF-11. Surface preparation was carried out using an MBX Bristle Blaster as grit blasting was not an option. After stemming weep, the pipe was wrapped with Belzona 1161 incorporating Belzona 9341 (Reinforcement Tape).
