GARBAGE ROOM FLOOR REPAIR AND COATING AT A MALL

Garbage room floors.

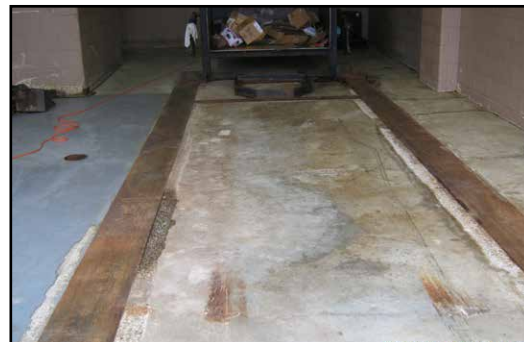
A combination of waste causing chemical attack and physical damage caused by large roll on, roll off containers.

1. Flooring prior to application
2. Application in progress
3. Complete application
4. Eighteen months after application

Application was carried out in accordance with Belzona Know-How System Leaflet FPA-1. The surface was prepared by removing any existing coating and loose material or contamination and abraded to expose the aggregate. Belzona 4131 was applied to rebuild and repair the damaged concrete. Belzona 5231 was applied to the garbage room floor with a roller in accordance with Belzona Instructions For Use.

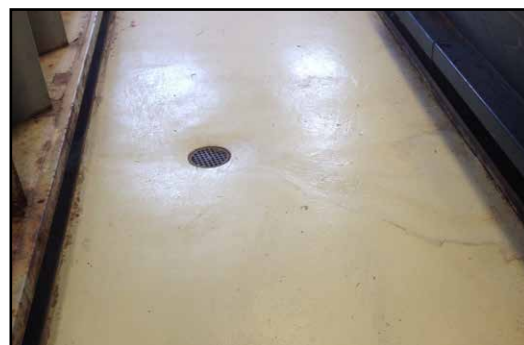
4.

The repairs and coating provide resistance to the daily activities, wear and attack. Eighteen months after application (March 2014) the system is performing excellent.
