SHAFT REPAIR AT WASTE WATER PLANT

Damaged shaft at a waste water plant

Shaft became worn due to bearing failure

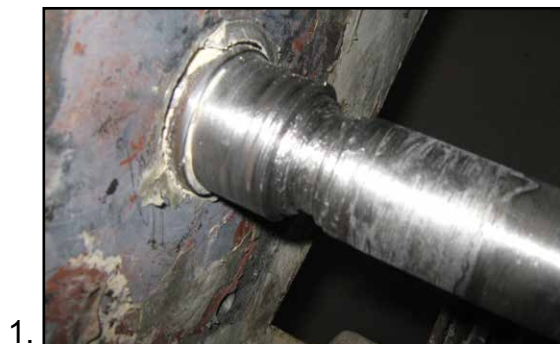
1. Shaft prior to the application
2. Application in process
3. Application with formers
4. Formers removed and application completed
