CORROSION PROTECTION FOR ROLLERCOASTER

Approximately 1700 Structural anchor bolts at the base of a roller coaster.

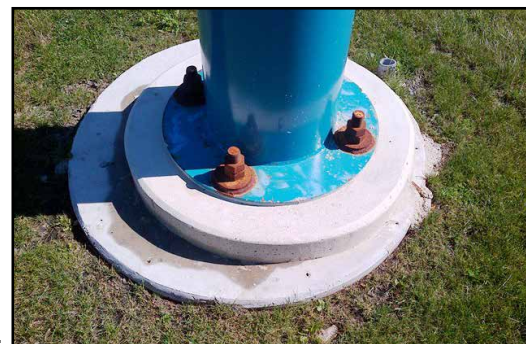
Uncoated and unprotected carbon steel structural anchor bolts exposed to outdoor elements causing Corrosion at a large theme Park attraction.

1. Anchor bolts prior to application
2. Application underway
3. View of an anchor bolt finished application
4. Completed application

The application was carried out in accordance with Belzona Know-How System Leaflet VPF-2. The surface was prepared by removing any contamination by rotary wire wheel and then cleaned with Belzona 9111. Two coats of the Belzona 5831 were applied with a brush to the anchor bolts in accordance with the Belzona Instructions For Use.
