BELZONA REPAIRS DAMAGED CONCRETE FLOOR

Textile manufacturer, Rochdale, UK

February 2014

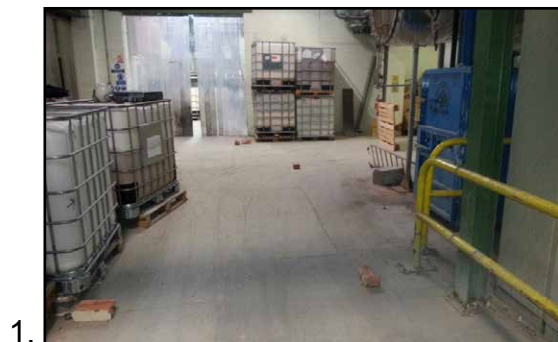
The floor was suffering from heavy wear in localised areas due to the heavy forklift truck traffic present on the site. This had caused damage to numerous areas of the concrete with a loss of depth in some areas of up to 10mm.

1. Damaged concrete floor
2. Application of Belzona 4111
3. & 4. Completed repair
