## BELZONA REPAIRS STEAM TRAIN FOR UNDERGROUND ANNIVERSARY

Locomotive repair workshop, Forest of Dean, UK

Corroded steam train engine

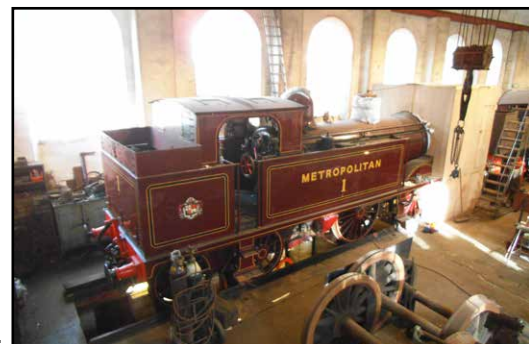
1. Metropolitan number one shown with a heated application hut built around the front nose section
2. Steam chest after grit blasting and application of Belzona 1511 under doubler plates bolted into place
3. Belzona 1391 applied over the doubler plates
4. Belzona 4181 applied as a final protection from foot traffic

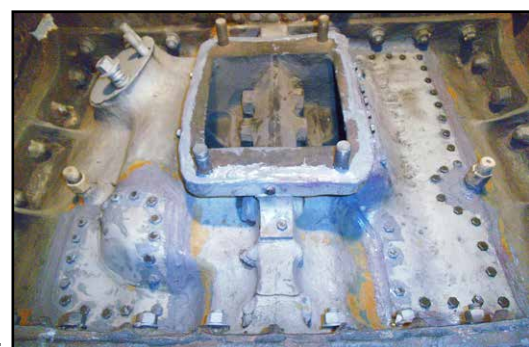
2.

The steam chest (part of the main cylinder block on the train engine) had corroded and had several holes due to steam pressure and the corrosive chemicals wearing it away over many years. Without fixing these holes the engine would lose pressure and fail to run.

Application was carried out in accordance with Belzona Know-How System Leaflets ENC-1 and modified FPA-1. Doubler plates were bonded in place with Belzona 1511 before being coated with Belzona 1391 to provide corrosion protection. Belzona 4181 was then applied to give additional corrosion resistance and resistance to foot traffic during maintenance work. The repair was then overlaid with fire clay to give an authentic appearance.
