ASSEMBLING PROPELLER RUDDER BEARING IN THE SHIP

Shipbuilding Yard / Russia

Two similar bearing lining applications completed in propeller rudder section.

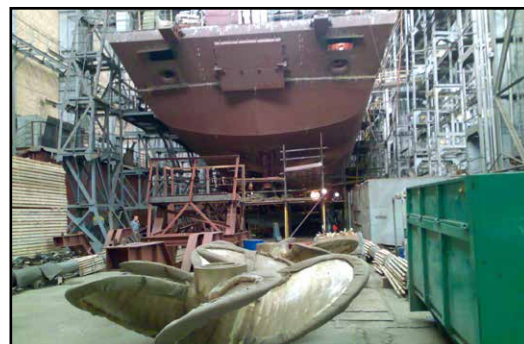
1. General back view of the ship
2. General view of a bracket with the exposed plug of the bearing
3. View of Belzona 1111 sealing between bearing lining and body frame of bracket before the injection
4. Injection of Belzona 1321
