## BELZONA REPAIRS THIN WALL DEFECT IN COOLING WATER SYSTEM

Nutritional products manufacturer, Dalry, Scotland

June 2014

Thin wall defect on cooling water pipework

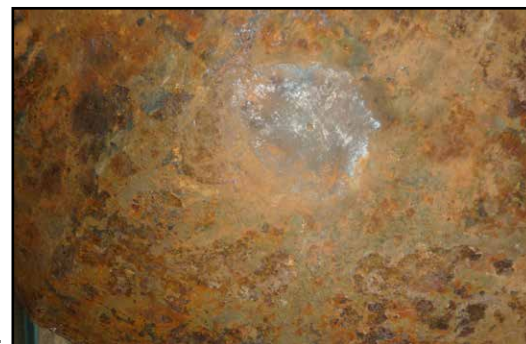
General corrosion had reduced original 10mm pipe wall thickness to 5-6mm but excessive grinding of the substrate during preparation for non destructive testing created a local defect with wall thickness of 2mm.

1. Local defect on the cooling water pipe
2. Defect measured
3. Return leg of cooling water system where repair required
4. Completed repair

Application was carried out in accordance with Belzona Know-How System Leaflets VPF-2 and VPF-11. A doubler plate was bonded using Belzona 1111 and was then overcoated with Belzona 1341.
