HOLDING PANS IN CHILLER UNITS NO LONGER CORRODING WITH BELZONA REPAIR

Holding pans in chiller units.

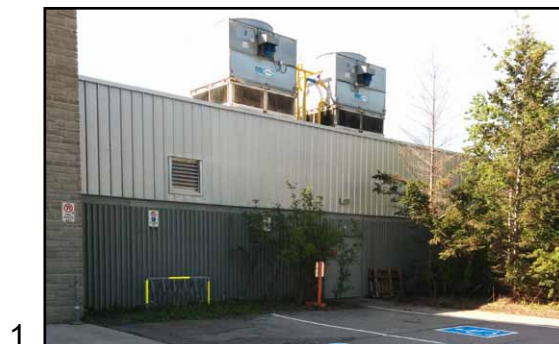
The holding pans in both of the chiller units had corroded and were leaking onto the roof.

1. View of the holding pans
2. Application in progress
3. Application in progress
4. Completed application

The application was carried out in accordance with Belzona Know-How System Leaflet TCC-15 for sealing and protecting containment areas. The unit was prepared using a grit blaster to remove all scale and corrosion. Belzona 1111 was applied to repair the holes and seal all the edges. Belzona 5811 was applied to the holding pans in accordance with Belzona Instructions For Use.
