## PIPE ELBOW REPAIRED AND PROTECTED WITH BELZONA

The pipe for the return air and media blast material from the blast machine.

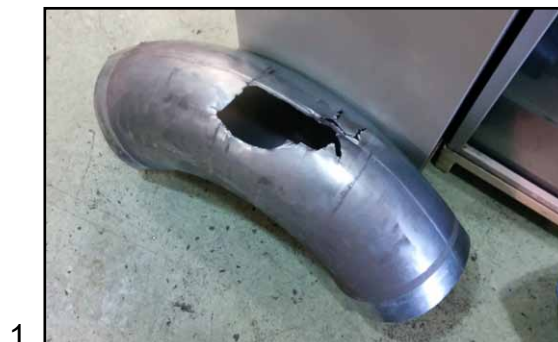
The blast material going through the pipe wore a hole to the side of the pipe elbow.

1. Prior to application
2. Application in progress
3. Completed application
