SPALLED STEPS NO LONGER A SAFETY HAZARD WITH BELZONA REPAIR

Stairs to a memorial recreation center.

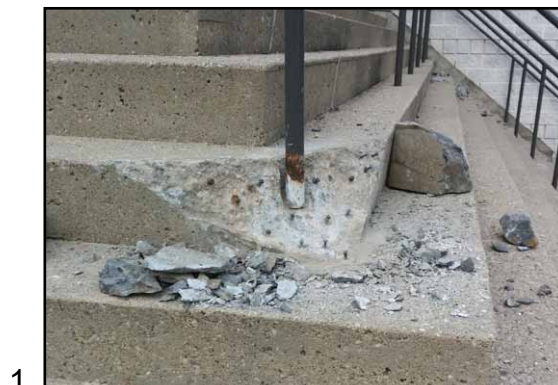
The stairs had spalled due to environmental freeze and thaw effect.

1. Prior to application
2. Completed application
3. Completed application

The application was carried out in accordance with Belzona Know-How System Leaflet FPA-10 for fixing or securing anchor bolts or hand rails. The surface was prepared using a grinder and the surface was brushed to remove any loose concrete. Belzona 4911 was applied to the area using a stiff bristle brush. Belzona 4131 was applied directly onto the conditioned surface in accordance with Belzona Instructions For Use.
