BELZONA STOPS TANK LEAK

Power Plant, Northern Texas, USA

Water Tank

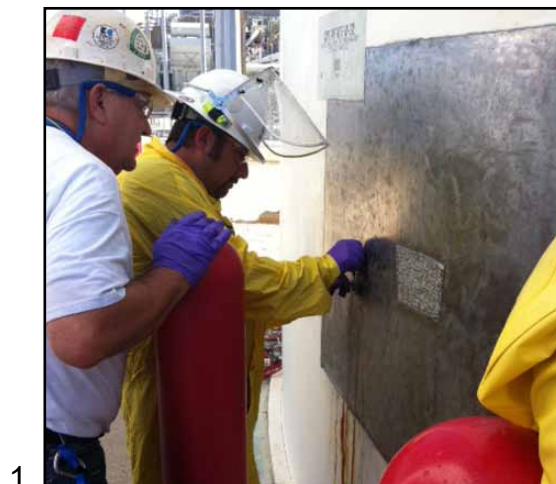
Emergency water tank was thin walled and leaking. Welding produced more leaks. The tank could not be taken out of service. Thin wall and leaks needed to be fixed while the tank was full.

1. Area to be repaired
2. Stopping leaks
3. Applying Belzona 1111
4. Completed repair

The application was carried out in accordance with Belzona Know-How System Leaflet TCC-1. The tank was blasted, which revealed three active leaks. The leaks were stopped with Belzona 1291. Then the entire area was coated with a fully reinforced Belzona 1111 with Belzona 9311.
