BELZONA BRINGS BACK LIFE TO 20 YEAR OLD TRANSFORMER

A 20 year old transformer is part of a substation which helps supply power to local residence.

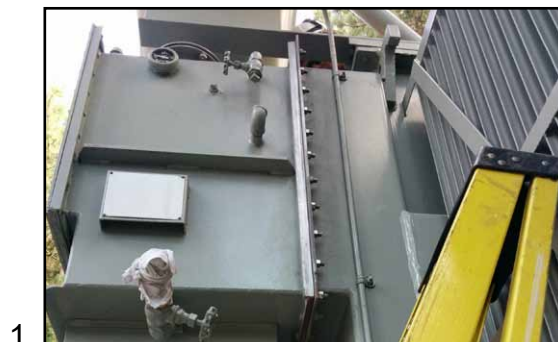
1. View of the transformer
2. Preparation in progress
3. Close up view of application
4. Completed application
