BELZONA REPAIRS AND PROTECTS CONCRETE AROUND HANDRAIL POSTS

Concrete around handrail posts at a Water Treatment Plant.

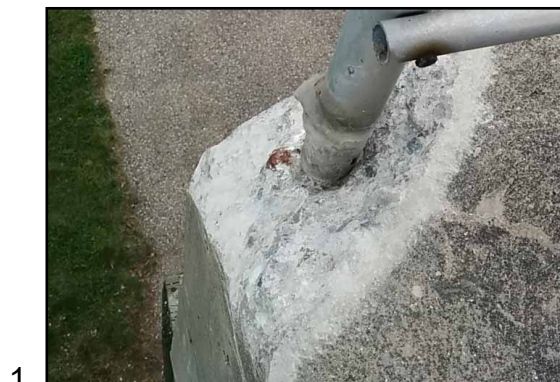
The concrete around the handrail posts was badly spalled. Some of the damage was from a combination of environmental (freeze thaw effect) and proximity of the concrete to the clarifier tanks.

1. Top view of damaged concrete
2. Side view prior to application
3. Top view of completed application
4. Completed application

The application was carried out in accordance with Belzona Know-How System Leaflet FPA-10 for fixing or securing anchor bolts or handrails. A grinder was used to prepare the surface and any loose concrete was removed. Belzona 4911 was applied to the prepared surface using a stiff bristle brush. Belzona 4131 was applied in accordance with Belzona Instructions For Use.
