BELZONA PROTECTS ROAD SWEEPER BOX AGAINST CORROSION

Road sweeper box.

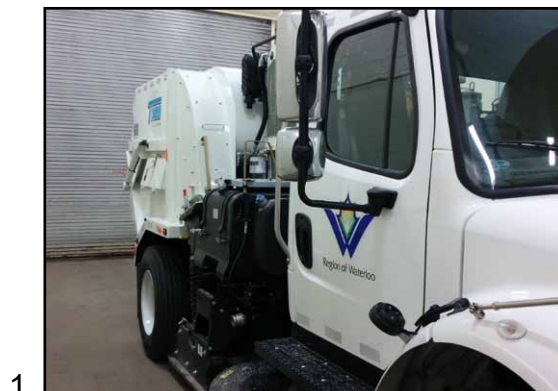
1. View of road sweeper
2. Prior to application
3. Completed application
4. Completed application

The application was carried out in accordance with Belzona Know-How System Leaflet TCC-3 for repairing/renewing damaged linings. A high powered pressure washer was used to prepare and clean the inside of the sweeper box. Belzona 6111 was spray applied to the surface as the first coat. Within the recommended overcoat time, Belzona 5111 was spray applied as the second coat.

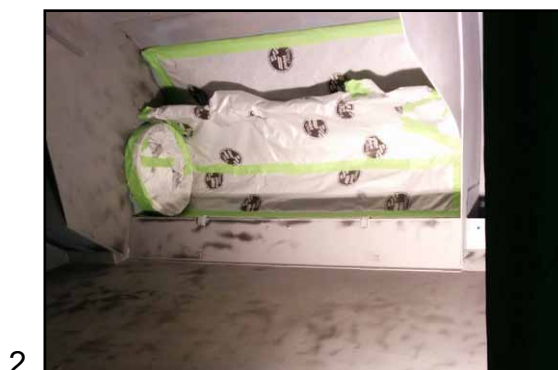
The sweeper box was suffering from corrosion from the inside, thus shortening the life of the unit.
