## BELZONA REPAIRS STAINLESS STEEL ARROW IN GRANITE

Dallas, TX, USA

August 2015

Arrow on floor

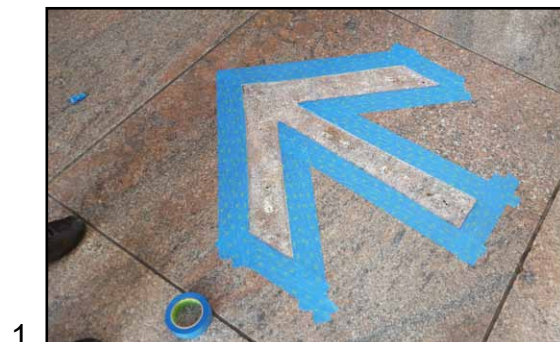
1. Surface prepared and masked off.
2. Belzona 4111 applied and weighed down to cure.
3. Waiting on material to cure. Only a 4 hour window.
4. Finished successful application.

The day before the application the back of the arrow was roughened using a diamond 4" disc grinder producing a very rough crosshatched surface. The granite was cleaned of old bonding material using a twisted wire brush. This left a thin layer of metal on the surface of the granite that would not wipe off. Klenztone #1 was used carefully only to the inside of the inset in the granite using a brush and a back and forth motion. This loosened the smeared metal. After sitting 20 minutes the Klenztone was removed with a bucket of water. The next day the granite was dry and any oil on the prepared arrow and granite was removed. The resins were mixed and a light coating of resins was applied to the back side of the arrow and the granite inset to ensure total contact of Belzona 4111. Aggregate was added to the mixed resin to produce a thick gravy type mix. This was applied to the bottom of the granite inset and the back of the arrow.
