HOTEL HOT WATER TANK RESCUE WITH BELZONA

Potable hot water tank at a large hotel.

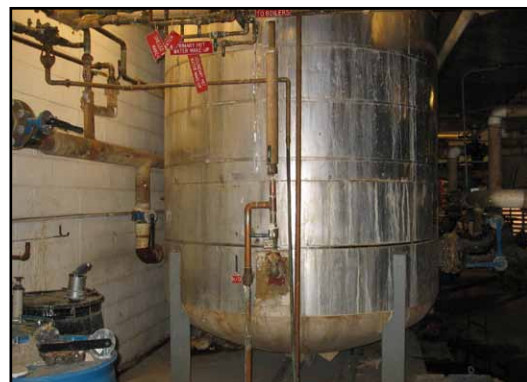
1. Hot water tank in the back corner of the mechanical room
2. Interior of the tank showing the corrosion and buildup of sediment
3. Interior repaired and ready for coating
4. Tank repaired and coated, looking like new!

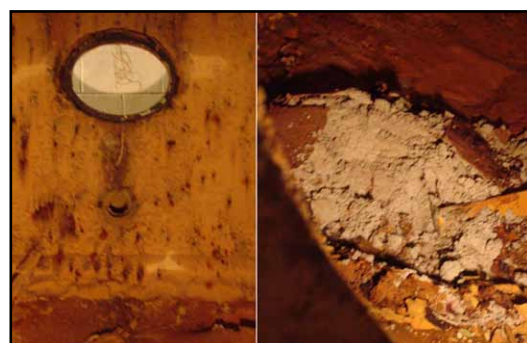
2.

The hot water tank had been built into the mechanical room in a way that it was impossible to remove and replace it without resituating the whole set up of the room. It had sufficient damage on the interior due to corrosion and buildup of minerals and sediment over the years.

The application was carried out in accordance with Belzona Know-How System Leaflet TCC-5. The substrate was first cleaned of loose debris with a chipping hammer then sandblasted to near white metal SSPC-10. It was tested for chlorides. All pitting and weld seams were filled with Belzona 1111, which accounted for about 90% of the substrate surface. Then it was coated with a dual coat system of Belzona 5891.
