BELZONA SMOOTHS AIRPORT RUNWAY

Airport, Northern Texas, USA

Airport runway

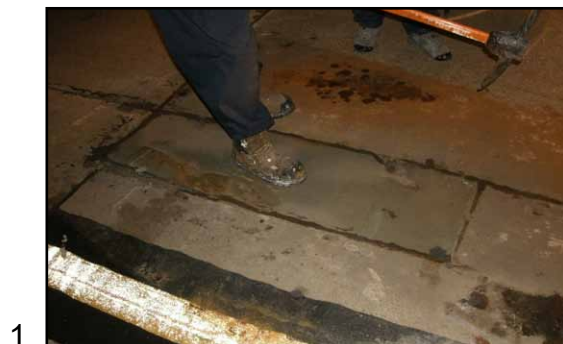
Prior patching material failed. A steel plate was used to cover the hole.

1. Old patch failed and removed
2. Hole prepared for application
3. Bulk material to fill the hole
4. Finished with pure Belzona 4111
