BELZONA REBUILD TRENCH DRAIN AT PAPER MILL

Paper Mill, Northern Texas, USA

2014

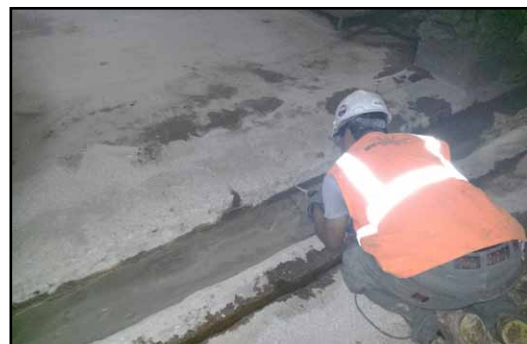
The concrete holding up the grate was so damaged that the grate fell into the trench.

1. Edges being prepared while drain is in use
2. Forms used to rebuild edges with Belzona 4111
3. Grate replaced over the trench
4. One year later, still performing well

The application was carried out in accordance with Belzona Know-How System Leaflet FPA. Loose concrete was chipped away and the edges were ground. A wood former was used to rebuild the edges to the original width and height.

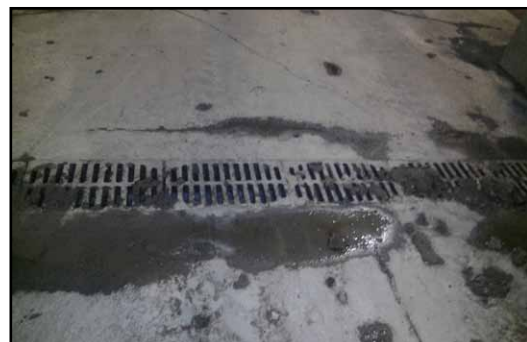
4.

One year later, the drain is in perfect condition. A conventional repair would have cost 10 times more and eliminated the use of the next room beyond the drain for two weeks. The Belzona repair took 18 hours, including cure time.
