BELZONA REPAIRS TURBO SEPARATOR AT PAPERMILL

40 year old separator at recycling paper mill.

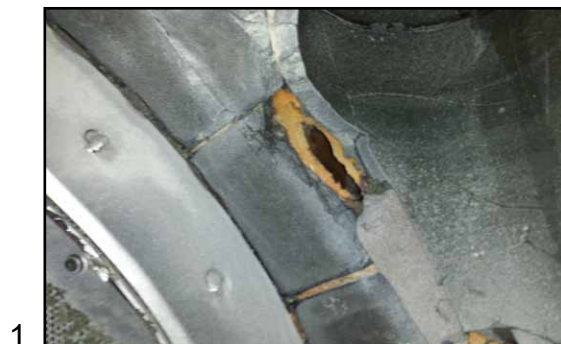
Extreme abrasion producing a hole through ceramic tile and steel causing a possible shutdown.

1. Hole in tile and steel.
2. Repair to hole with Belzona 1811.
3. Repair to other areas of separator.
4. View of separator.

The application was carried out with a modified version of Belzona Know-How System Leaflet CEP-6. The job timeline was critical. For surface preparation, the areas were aggregate blasted. Belzona 1811 was applied with a backer plate over the hole. Belzona 1811 was then applied over other worn areas. The vessel was force cured for start up.
