REPAIRING COOLING TOWER SEAMS WITH BELZONA

Hospital, North Carolina, USA

Roof-mounted cooling towers (2 cells joined into 1 tower).

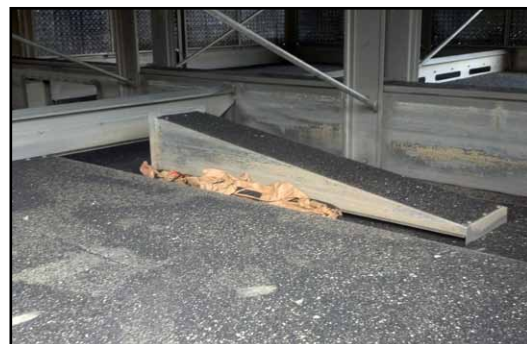
1. Blasting completed, prior to media removal
2. Taping and conditioning all seams/protrusions
3. First coat of Belzona 2131, embedding Belzona 9341
4. Completed application to towers

The application was carried out in accordance with Belzona Know-How System Leaflets HEX-6, HEX-13, TCC-12, FPA-6 and a modified version of FPA-7. The substrate was prepared via media blast with Black Beauty, cleaned, taped, and then conditioned with Belzona 2911. Once cured for 1/2 hour, a two-coat reinforced system of Belzona 2131 was utilized to create a polymer overlay over all assembly seams/joint. Bolt holes and other protrusions were top-dressed with a coating of Belzona 2131.
