CONCRETE STEP REPAIR WITH BELZONA

Building & Structures, North Carolina, USA

August 2015

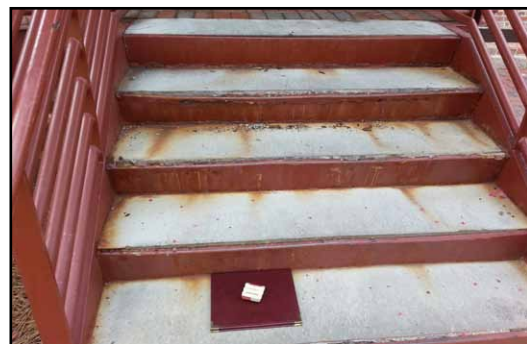
Concrete steps were broken and deteriorating.

1. Prior to application
2. Preparing the surface by removing busted concrete
3. Application of Belzona 4411 with some aggregate
4. Completed application

The old concrete was removed so that Belzona 4111 could fill in the spots. After the steps were smoothed over, Belzona 4411 was added with some aggregate.
