## BELZONA REPAIRS FGD WET LIME SLURRY DISTRIBUTION BOXES

Power Plant, Illinois, USA

Early Summer 2015

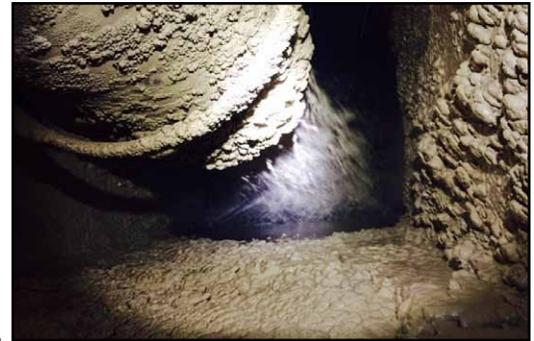
1. Lime slurry being poured into the box
2. Distribution box had been laid on its side for the application to start with welded plate covering one hole visible in the cyclone area
3. Belzona 9811 being installed on top of a wet layer of Belzona 2111
4. Belzona 1812 being installed as a grout and void filler

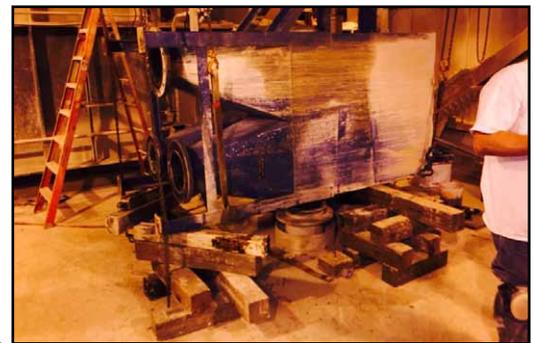
2.

Lime slurry had worn away the existing rubber liner through the steel, and had created holes and washed out areas towards the bottom of the boxes in the cyclone areas.

The application was carried out in accordance with Belzona Know-How System Leaflet SHM-7. Surface preparation was done by using a MBX bristle blaster and Belzona roughing brushes. Belzona 1121 was used to seal all holes and rebuild the metal substrate back to its original thickness. Then, Belzona 2911 was used to condition the surface. Belzona 2111 was applied to rebuild worn rubber areas and it was also used as a bonding agent for Belzona 9811. A layer of Belzona 9811 wear tiles was embedded into Belzona 2111 to help absorb the impact behind the tiles. Belzona 1812 was then used as a grout and to fill/seal any voids.
