LIVE WATER LEAK CLAMPED WITH BELZONA

Hospital, Northern Texas, USA

Hot water line at a hospital

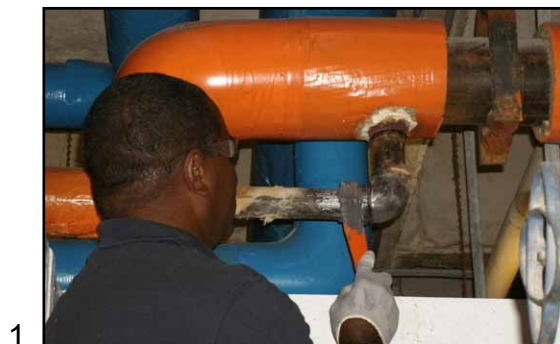
The hot water line was leaking from an expansion tank to the 2" line. The supply of hot water could not be shut off since it fed water to the emergency room.

1. Leaking pipe cleaned
2. Clamp ready to go
3. Application of Belzona 1111
4. Clamp installed

A clamp was fabricated at a machine shop. The clamp had a threaded drain and matched threaded fittings. Belzona 1111 was applied to secure clamp to the hot water line.
