CLARIFIER HEADWORKS GET QUICK FIX WITH BELZONA

Waste Treatment Plant, Northern Texas, USA

Chemical attack to headworks of clarifier.

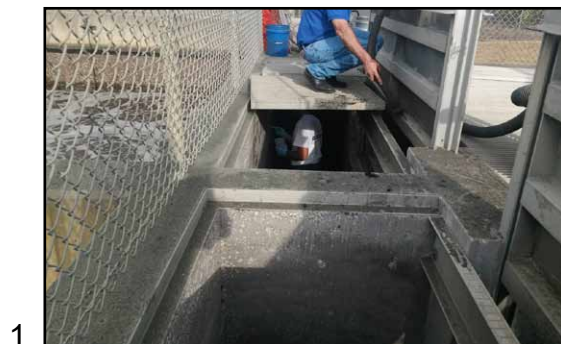
1. Blasting the headworks
2. Bugholes filled with Belzona 4111
3. Application of the first coat of Belzona 5831
4. Application of the final coat of Belzona 5831

The application was carried out in accordance with Belzona Know-How System Leaflet TCC. The concrete was blasted and bugholes were filled with Belzona 4111. Two coats of Belzona 5831 were then applied.
